Profile System Software 2.5.6 Release Notes

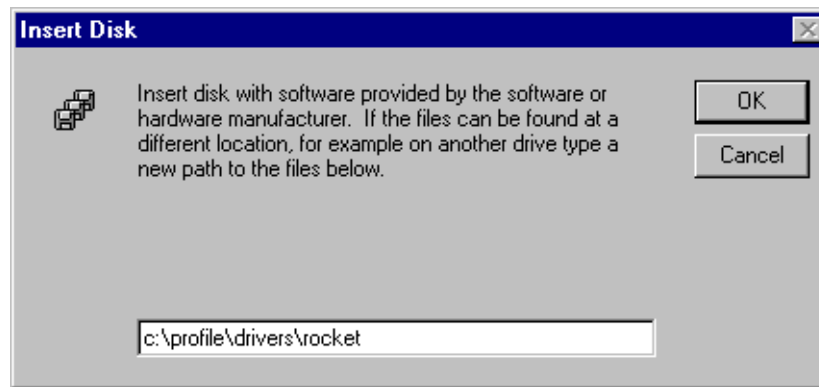
-
2. Open the Control Panel by choosing **Start | Settings | Control Panel**.
 3. Double-click the **Network** icon.
 4. The Network dialog box appears. Click the **Adapters** tab.
 5. Click the **Add** button, and then the **Have Disk** button.
 6. When you are prompted, type **c:\profile\drivers\rocket** as the path of the directory containing the driver files (see Figure 1) and click **OK**.

Figure 1. Type the path to the device driver files

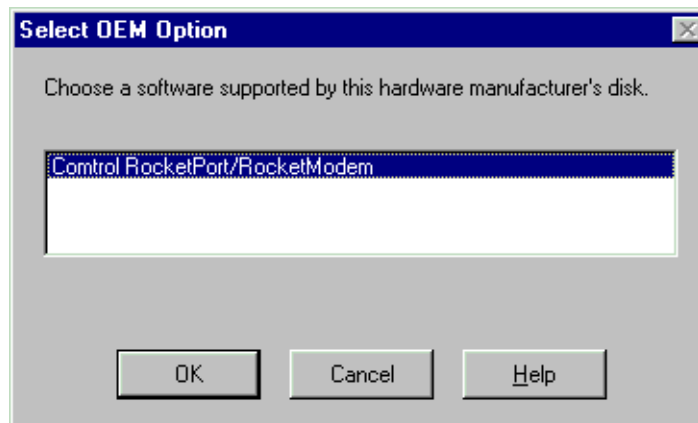
7. The Select OEM Option dialog box appears (see Figure 2). Ensure that the Control RocketPort RocketModem is selected, then click **OK**.

Figure 2. Select the RocketPort driver.

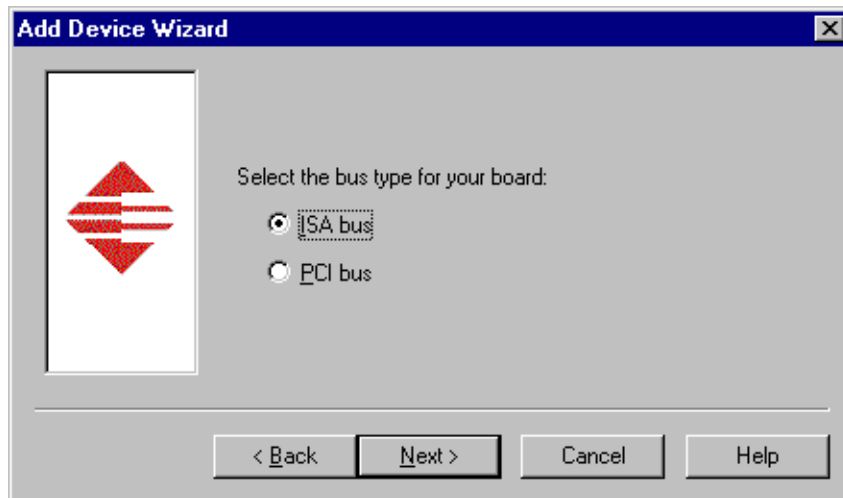
8. The Add Device Wizard starts. Click **Next** to continue, then select ISA bus as the bus type (see Figure 3) and click **Next** again.

Figure 3. Select the ISA bus type.

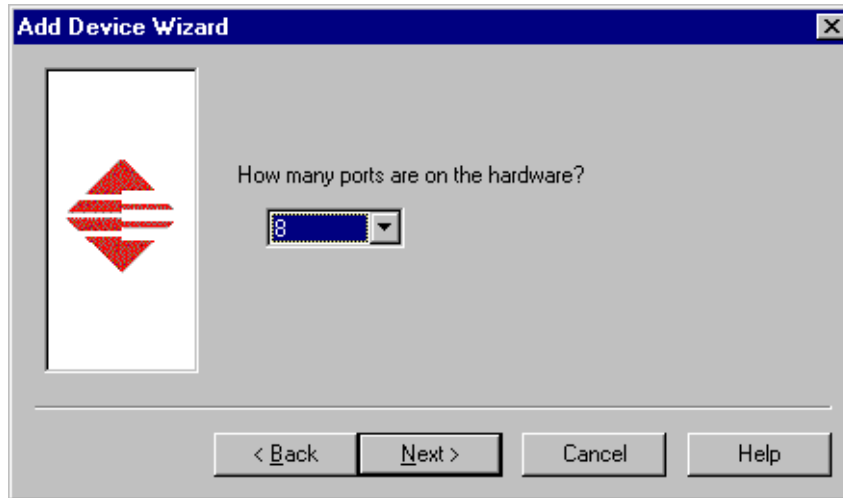
10. Select eight ports on the hardware (see Figure 5), then click **Next**.

Figure 5. Select eight ports.

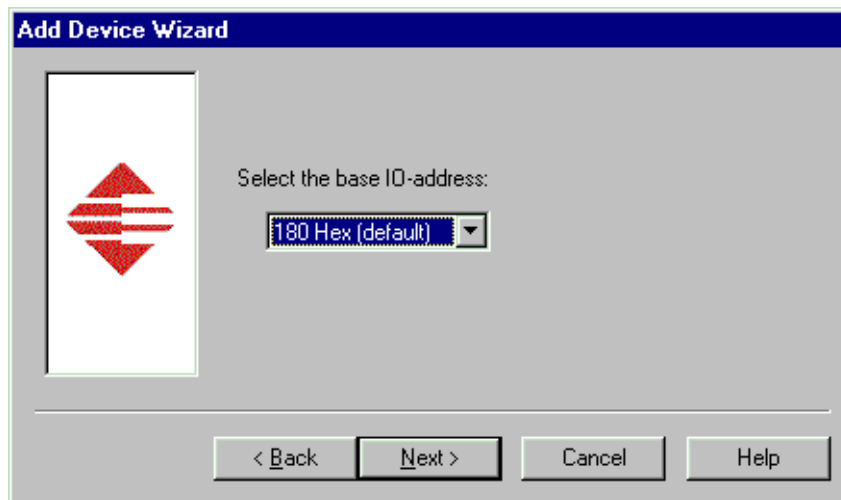
11. Set the I/O Base Address to 180 Hex (see Figure 6), then click **Next**.

Figure 6. Set the I/O Base Address to 180.

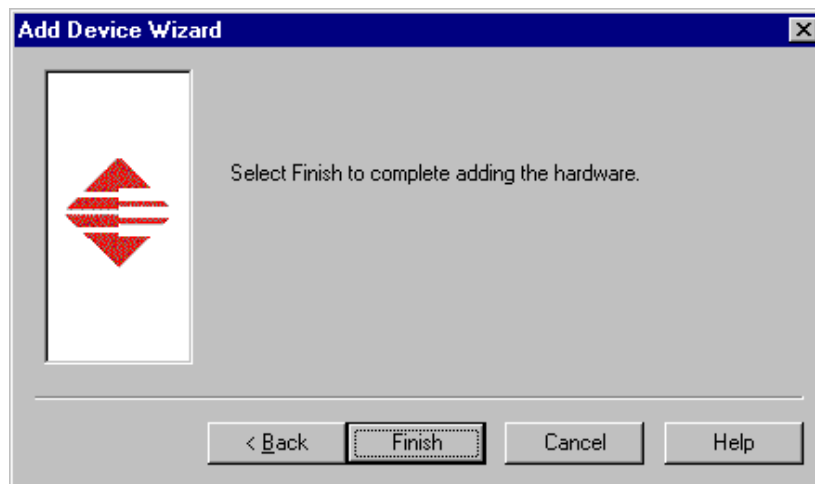
12. Click **Finish** to close the Add Devices Wizard (see Figure 7) and open the Device Properties dialog box.

Figure 7. Finish the driver installation.

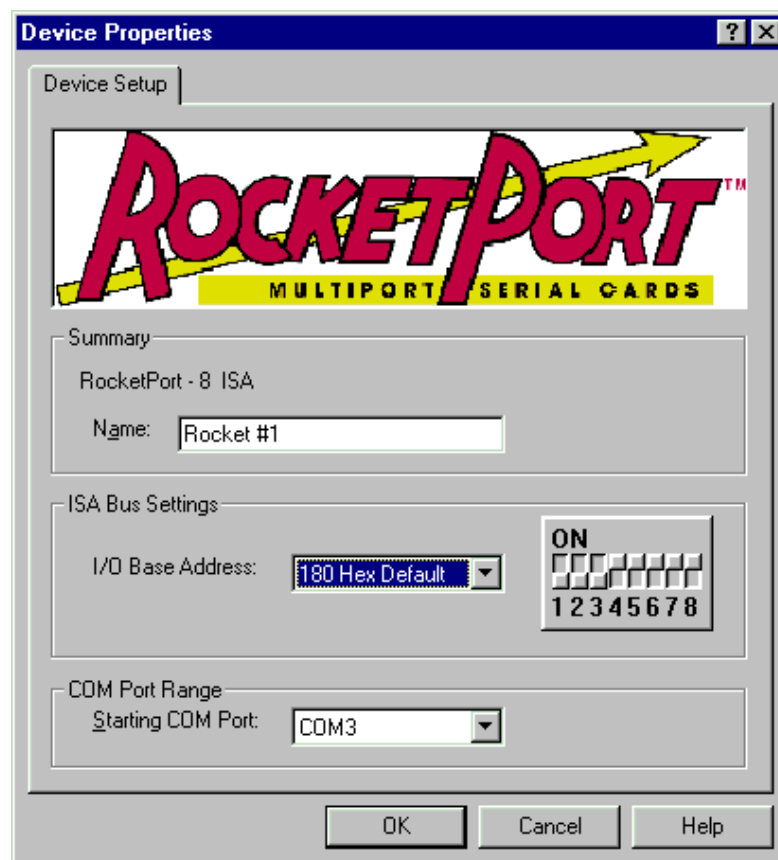
13. Ensure that the Starting COM Port is set to **COM3** and that the I/O Base Address is set to **180 Hex**, then click **OK** to close the Device Properties dialog box (see Figure 8).

Figure 8. Select COM3 as the starting port.
